BOA Smart Cameras Solve A Pressing Problem

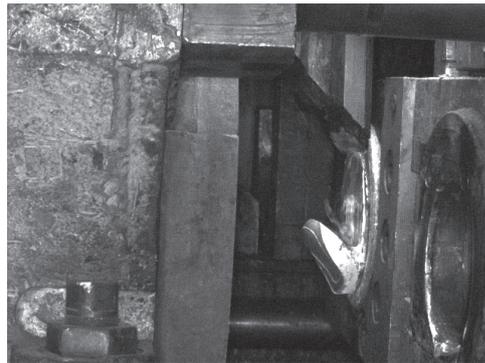
Bad cut: When a billet is not cut properly, the BOA alerts a PLC, which then shuts down the machine.

The other BOA takes images of the knife when it drops to cut the billet and when it returns to its original position. If the image indicates that the excess aluminum was sheared off, then the hydraulic press and plunger resume operations. If the image shows that the billet was not cut properly, the BOA sends a message to an Allen-Bradley PLC, which stops the machine and activates an alarm alerting workers to the problem.

The BOA software contains an extensive library of tools for solving most vision applications. At Silver City, a simple pattern matching technique is used. "We look at a clean cut and teach the system to run that specific pattern," says CPU automation engineer Mike Bray. "The image gets a score of 100% if it's an exact match, then the score drops with any variations. Any big fluctuations that occur—say, down to 20%—causes the BOA to alert the PLC to a failure."

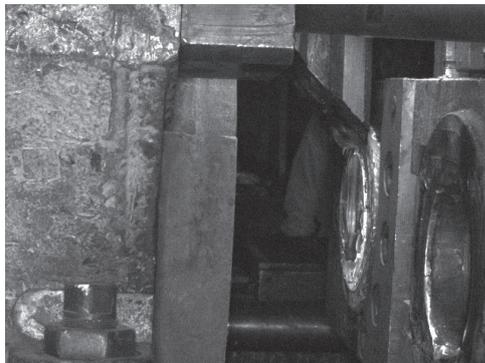
Good cut: This BOA image shows a "good cut," when excess aluminum has been sheared off the billet.
